**WEST VIRGINIA DEPARTMENT OF ENVIRONMENTAL PROTECTION
WV/NPDES CONSTRUCTION STORMWATER PERMIT**

FACILITY NAME:	RAN 5 Project			REG. #	EXPIRE DATE:
PERMITTEE	ROXUL USA INC.			WVR108876	12/31/2018
ADDRESS/PHONE:	Attn: KENNETH J. CAMMARATO 4594 CAYCE RD BYHALIA, MS 38611 6628514734				
LOCATION:	ROXUL USA INC., ROXUL USA INC.			Entry Date/Time:	10/2/18 8:00am
COUNTY:	Jefferson			Exit Date/Time:	10/2/18 10:30am
Site Representative /Phone	All Construction			PHOTOS <input checked="" type="checkbox"/>	
CO-PERMITTEE:			ADDRESS:		
SITE OPERATOR:	Chip Mullenex		ADDRESS:		
PERMITTED ACREAGE	98.8	WEATHER:	Clear	LAST INSPECTION:	09/11/18
RECEIVING STREAM(S)	Rockymarsh Run/Potomac River				NOV: 0
Regular Mail <input checked="" type="checkbox"/> Certified Mail <input type="checkbox"/>	Tracking #				
OVERALL FACILITY RATING:	Unrated		COMPLIANCE OUTCOME	No Violation

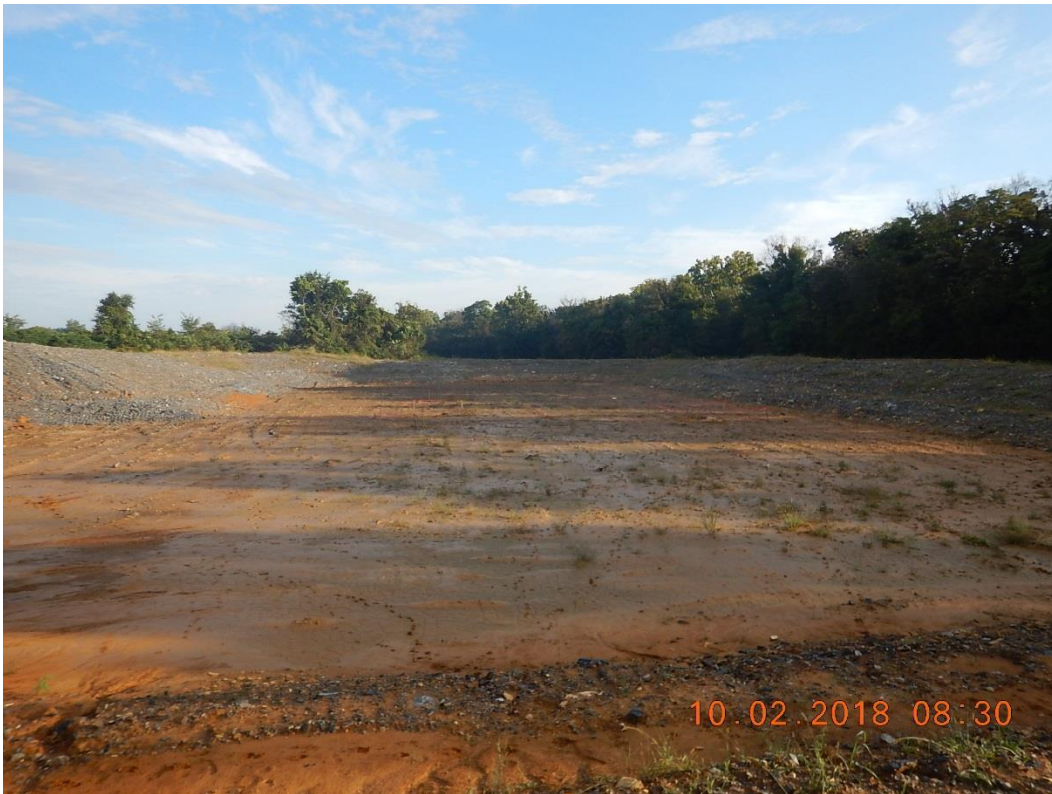
Overview of 5 potential sinkholes in the reuse pond.

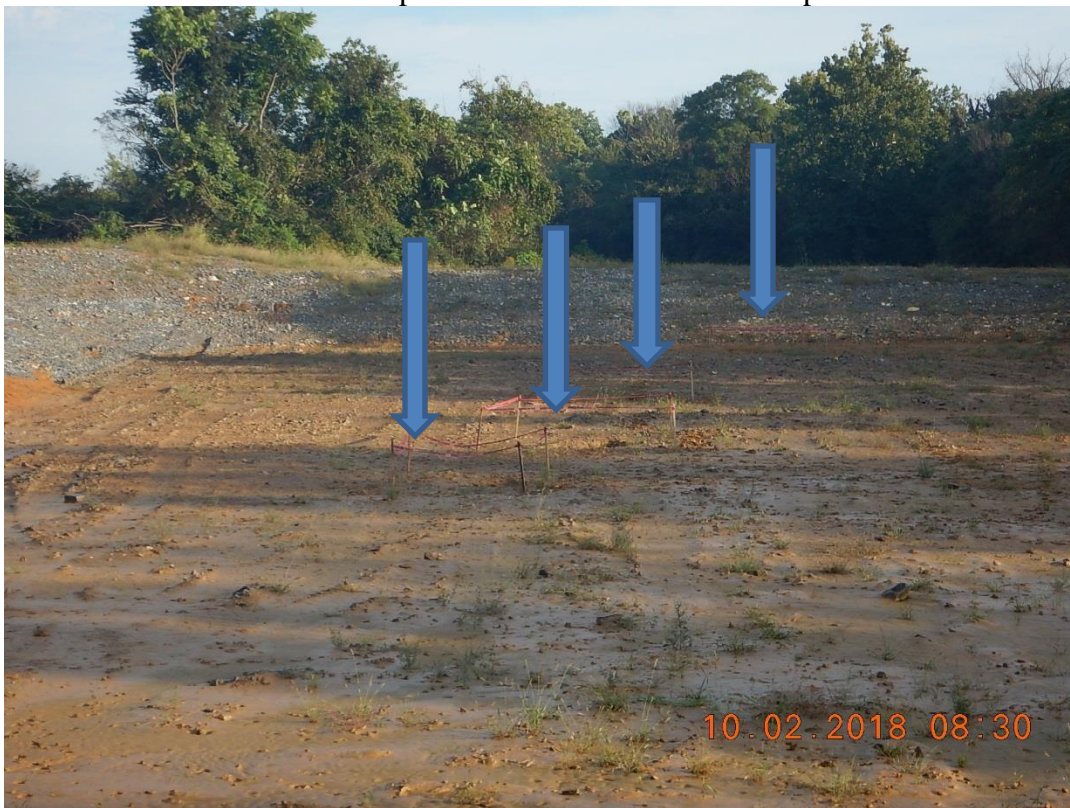
Four sinkholes pictured in the reuse pond.

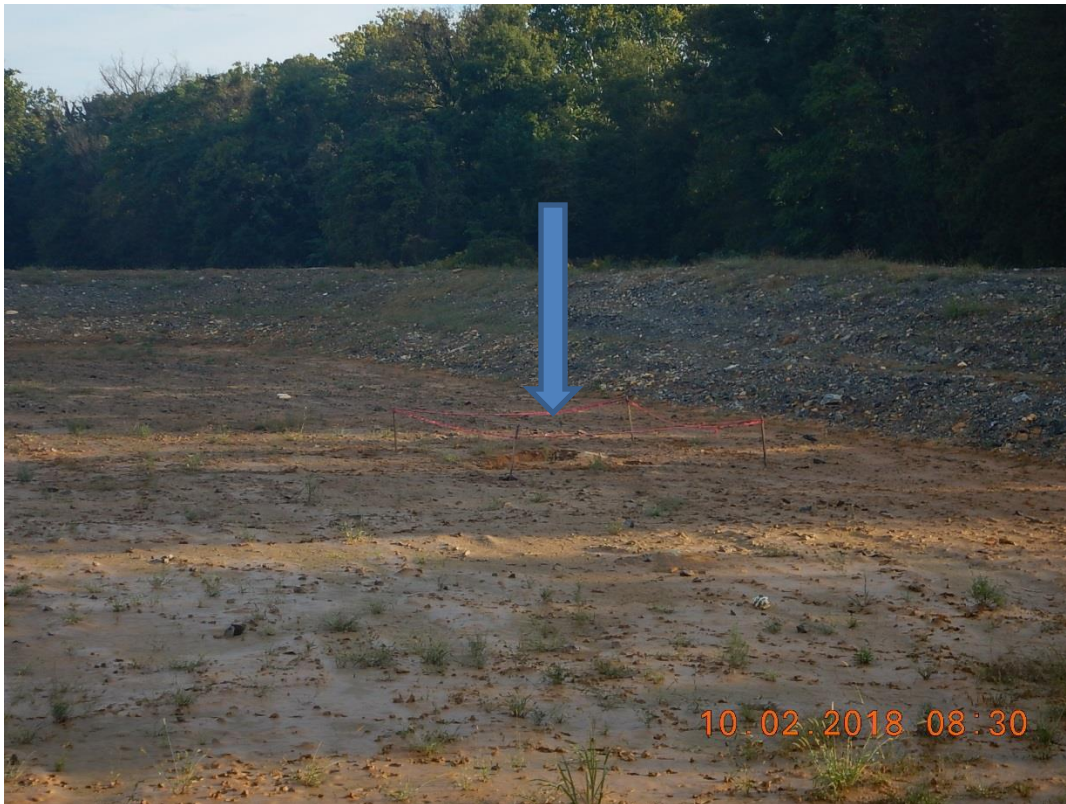
Fifth potential sinkhole pictured in the reuse pond.

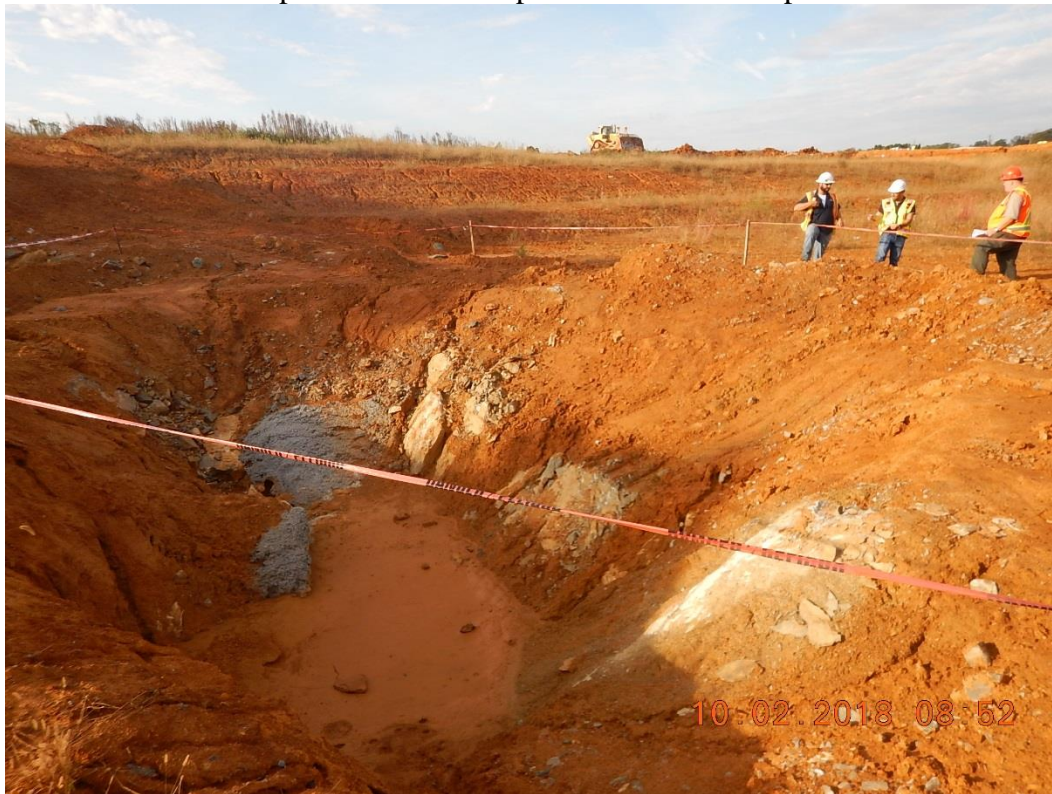
Sinkhole in Basin #1

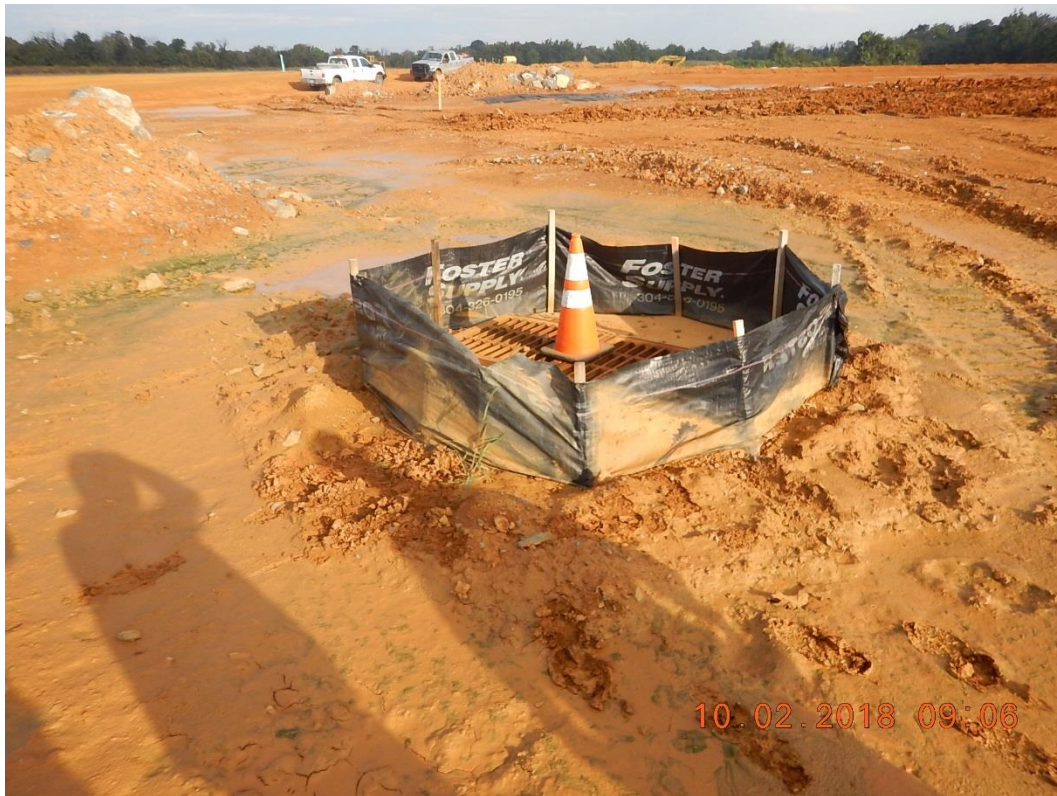
Sinkhole # 7 capped under concrete drop inlet structure.

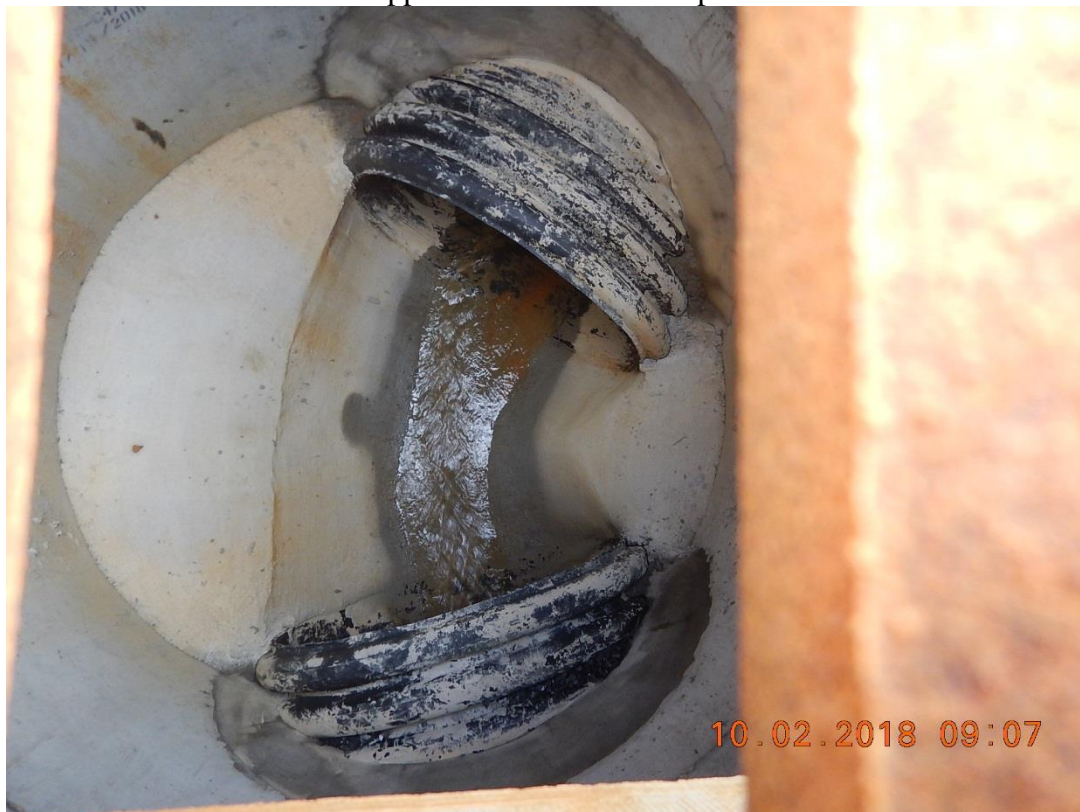
Inside of the drop inlet pictured above of sinkhole #7.

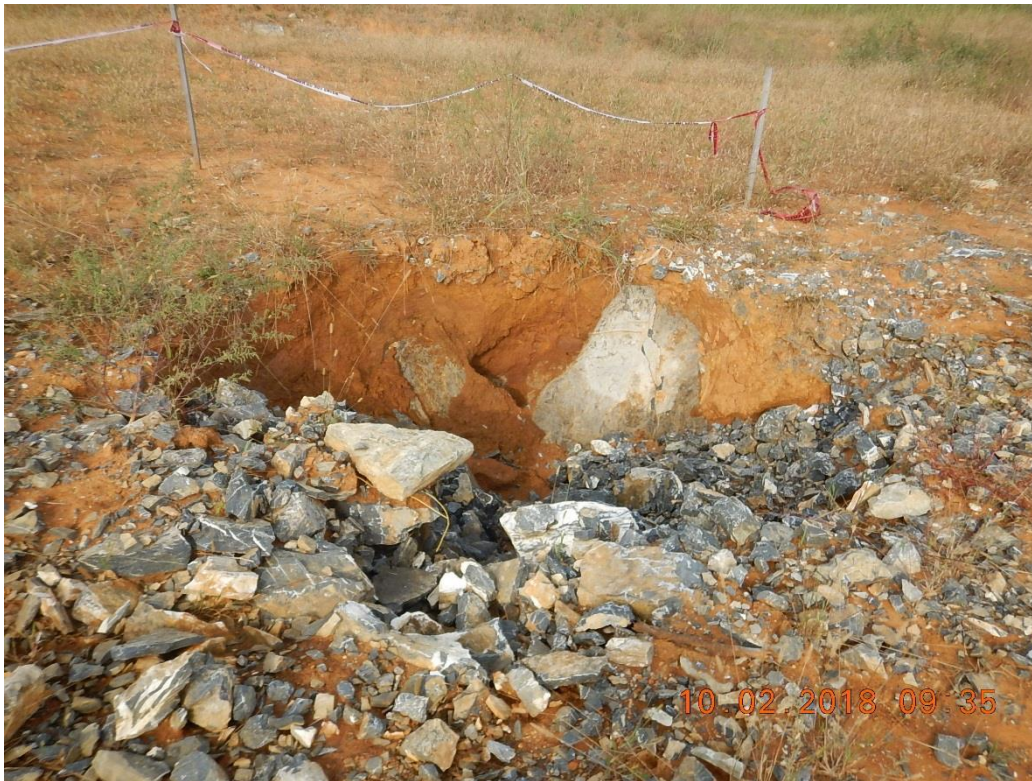
Sinkhole in basin #2.
